**LEWIS MILL**

**2012 Stabilization Project**

**San Miguel County, Colorado**

**FINAL REPORT**

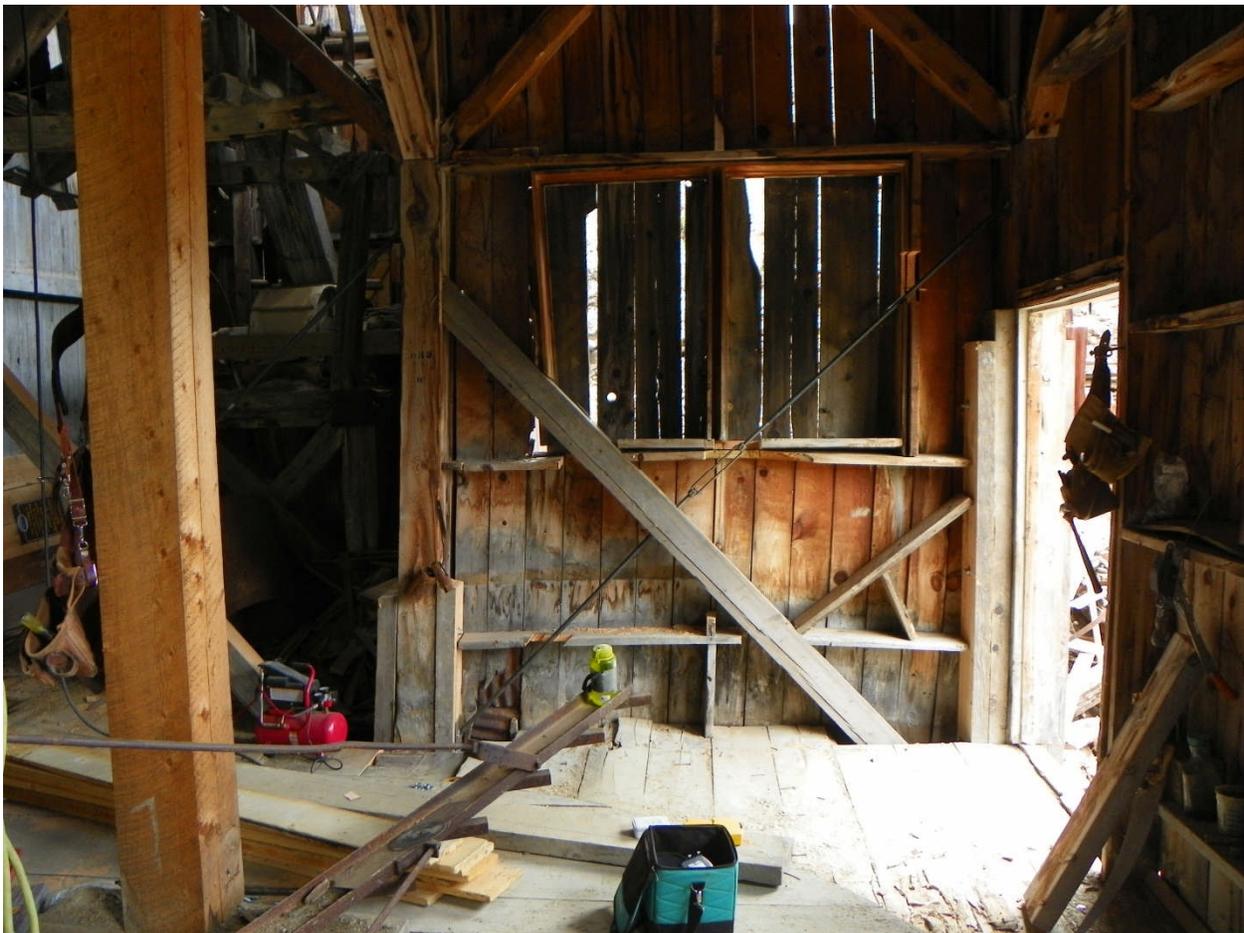
Figure 1

Cross bracing was installed between level 2 and 3 along Grid line 4 – between Column Lines F & G; and between E & F. 1 inch diameter steel rod w/turnbuckles and welded attachment brackets were installed for tension members. 6 x 6 timber was installed for compression members. The bottom of the timber braces were secured to the existing wood sill by fabricated metal ‘buckets.’ The sill along Grid line 4 below level 1 is mounted on the rock foundation and was determined to have minimal deterioration.

Stabilizing Bracing between Column Lines F & G along Grid 4

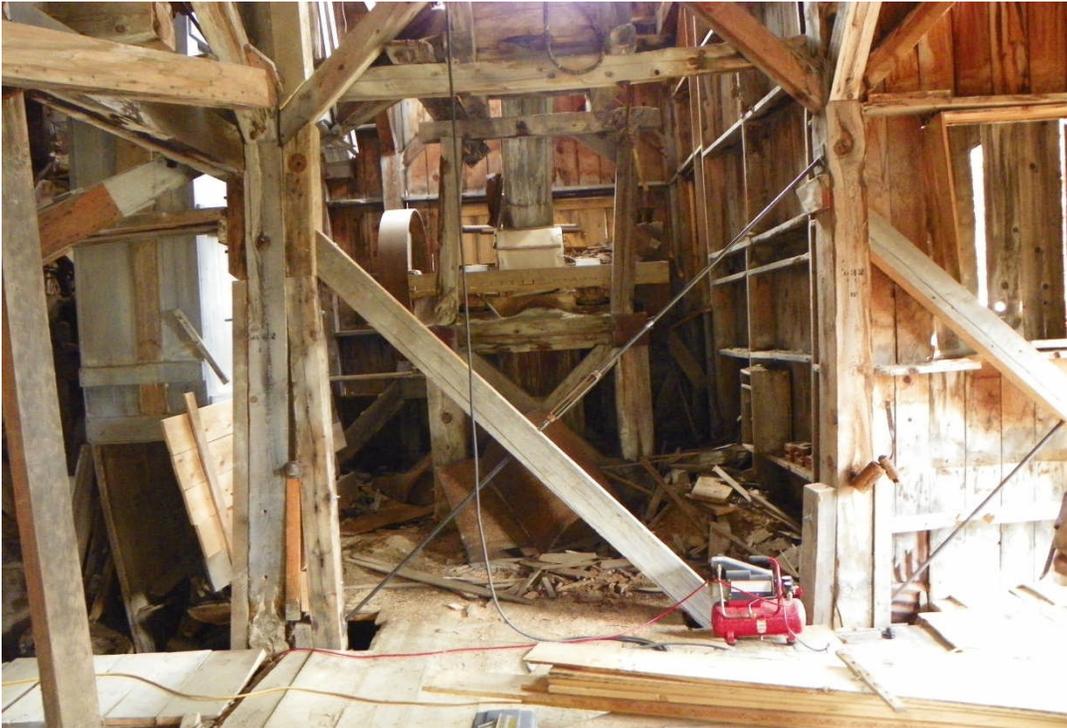
Figure 2

Stabilizing Bracing between Column Lines E & F along Grid 4

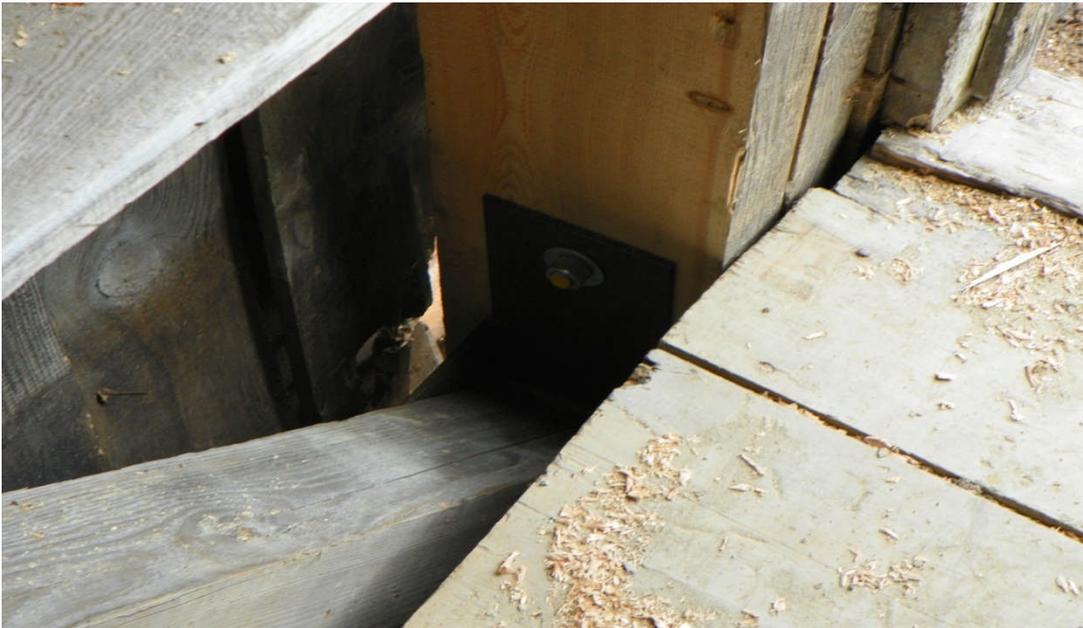
Figure 3

Supporting 'Bucket' on Sill (typical)

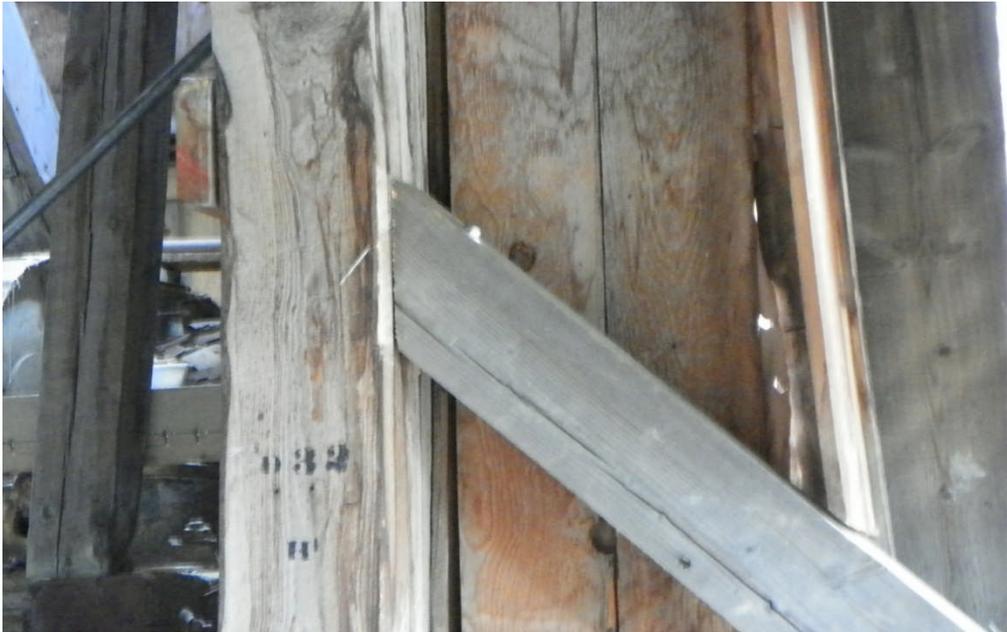
Figure 4

Top Compression Brace Connection (typical)

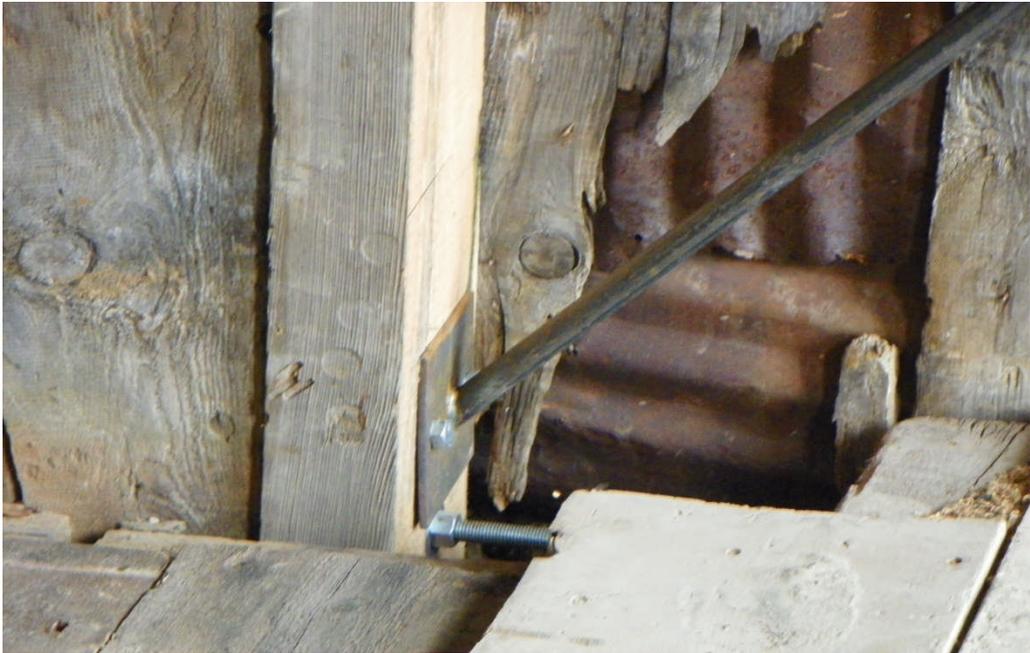
Figure 5

Tension Member Connection (typical)

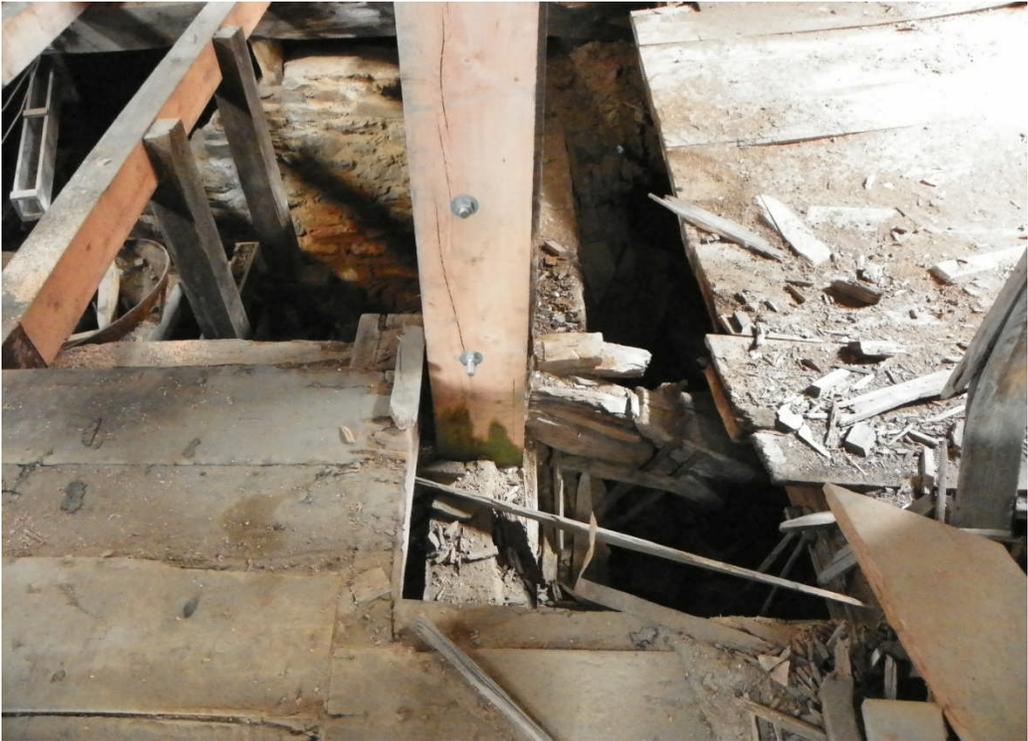
Figure 6

Column 4E required extensive reinforcement due to deformation. Columns 4C and 4b were reinforced as shown. Columns 4C and 4B were reinforced by installing helper columns from the base part way up the column. These were secured with through bolts.

Reinforcement of Column 4C Base

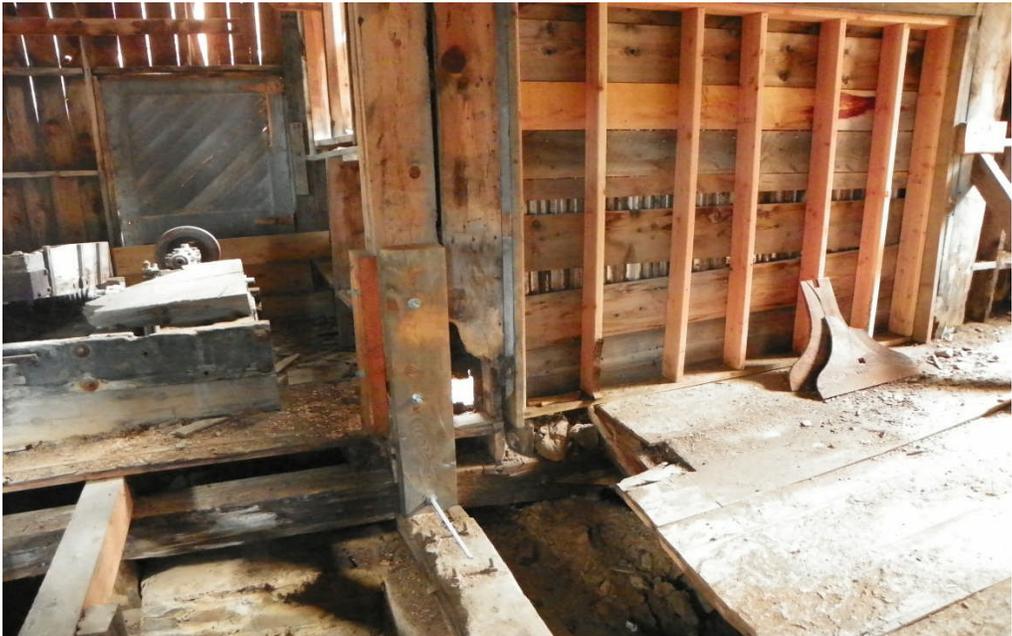
Figure 7

Reinforcement of Column 4B Base

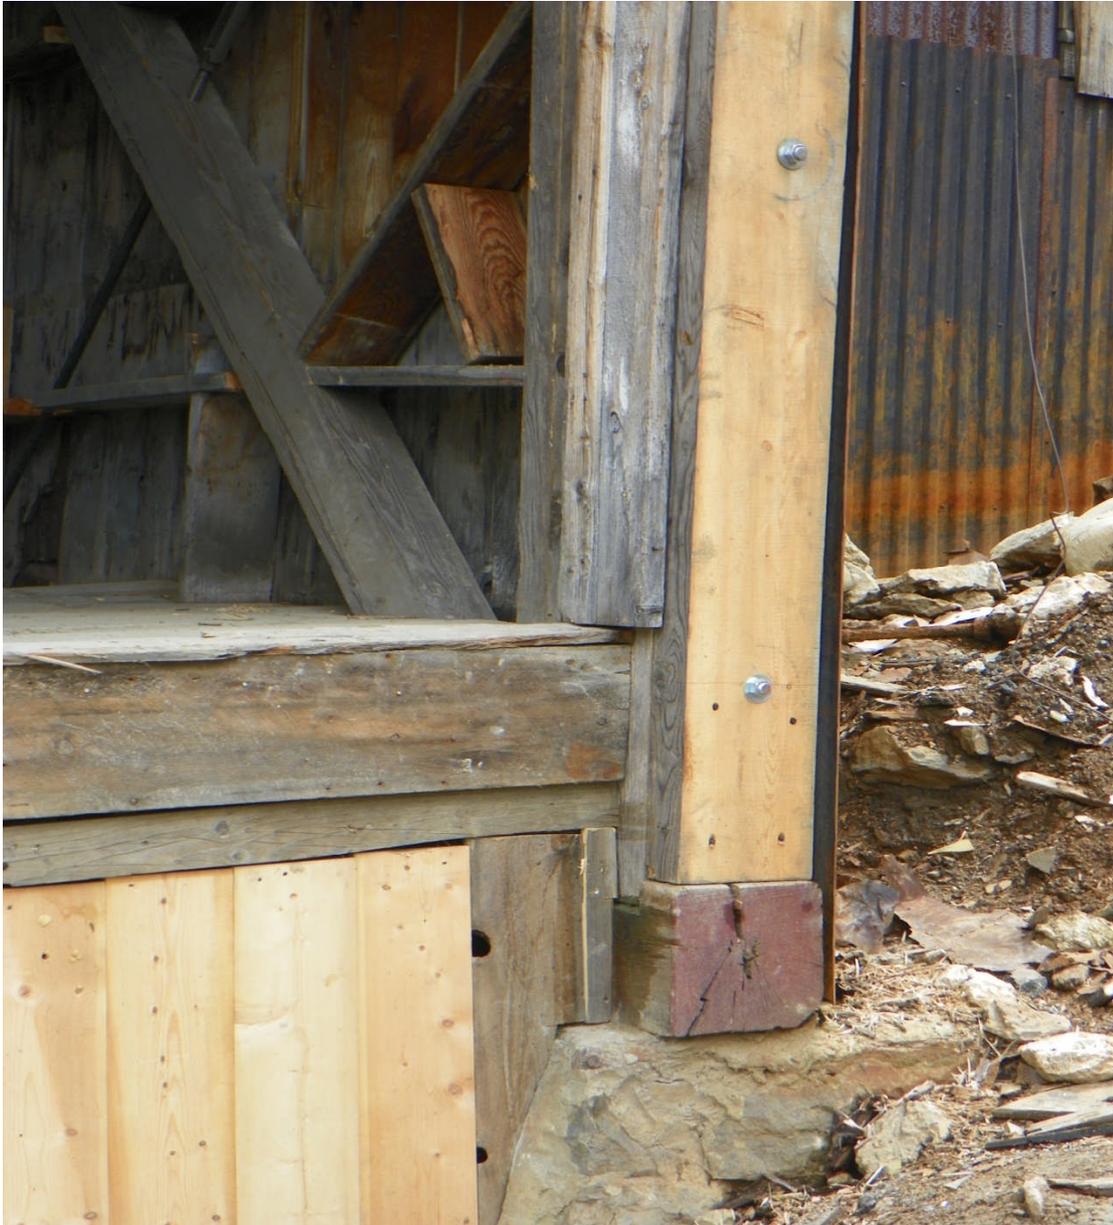
Figure 8

The bottom of the column was rotten and had shifted slightly to the north. It was determined that the sill timber on top of the rock foundation was sound. Sister columns (3x8) were bolted on both sides of the column for support, and the rotten section of column 4G removed. This was replaced with a sound section to carry the load in compression, and the assembly secured with through bolts. The outer metal covering was replaced to help protect the column from future deterioration.

Outside Column 4G Sister Timber Setting on Timber Sill and Rock Foundation

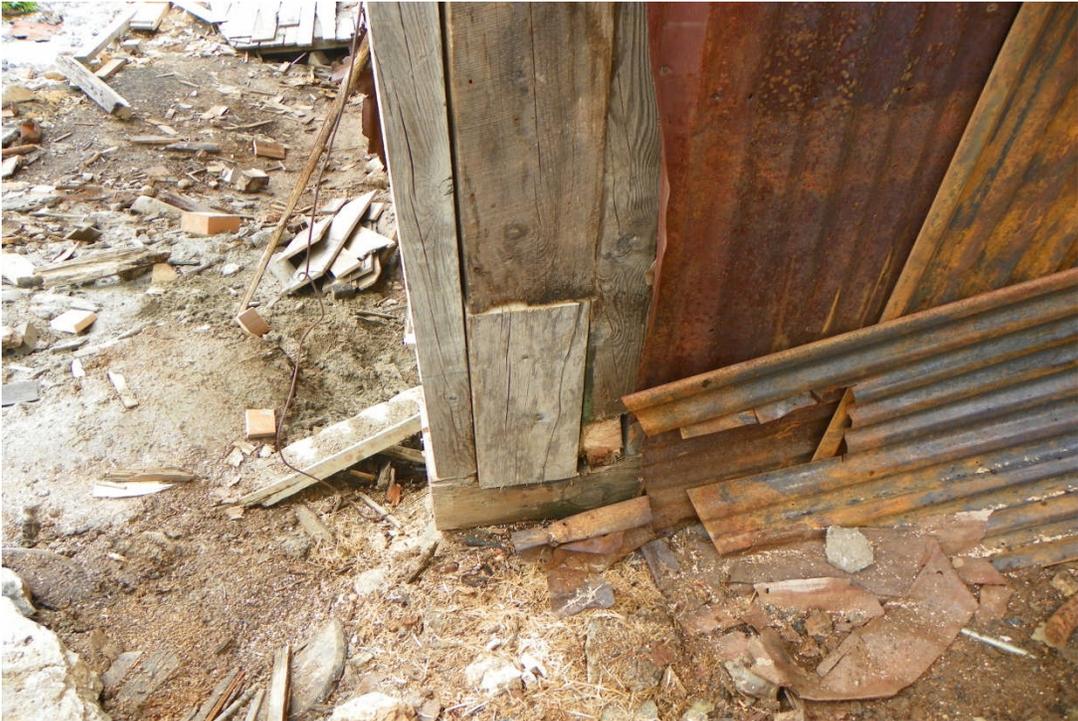
Figure 9

New Compression Section for Column 4G and Sister Reinforcements on Each Side

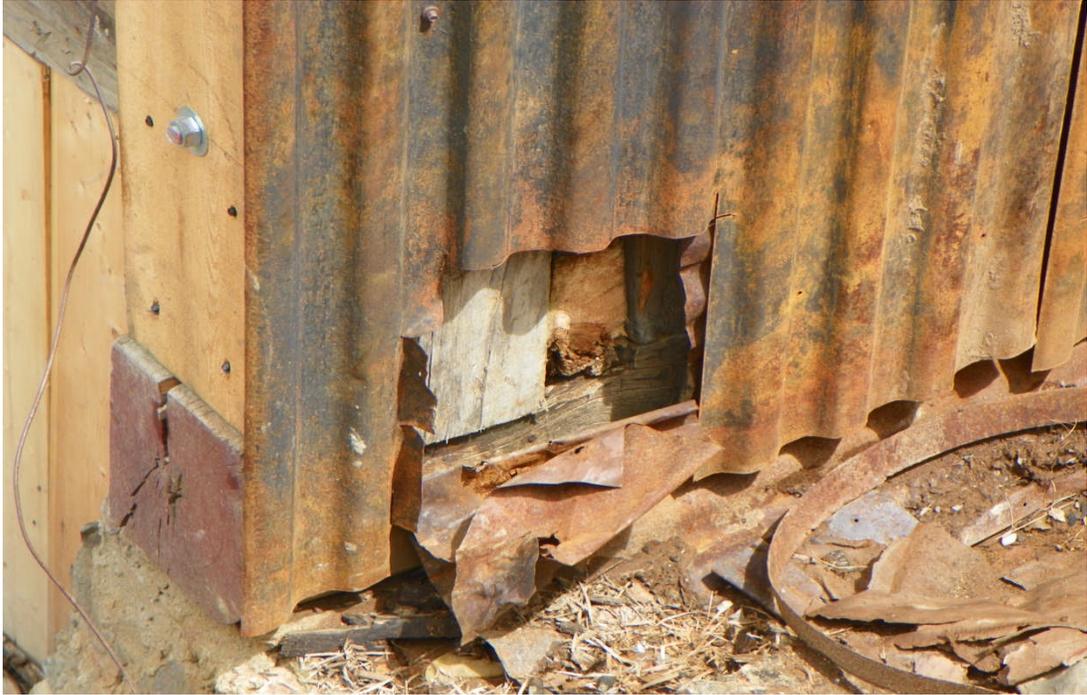
Figure 10

Metal Covering Replaced at Column 4G

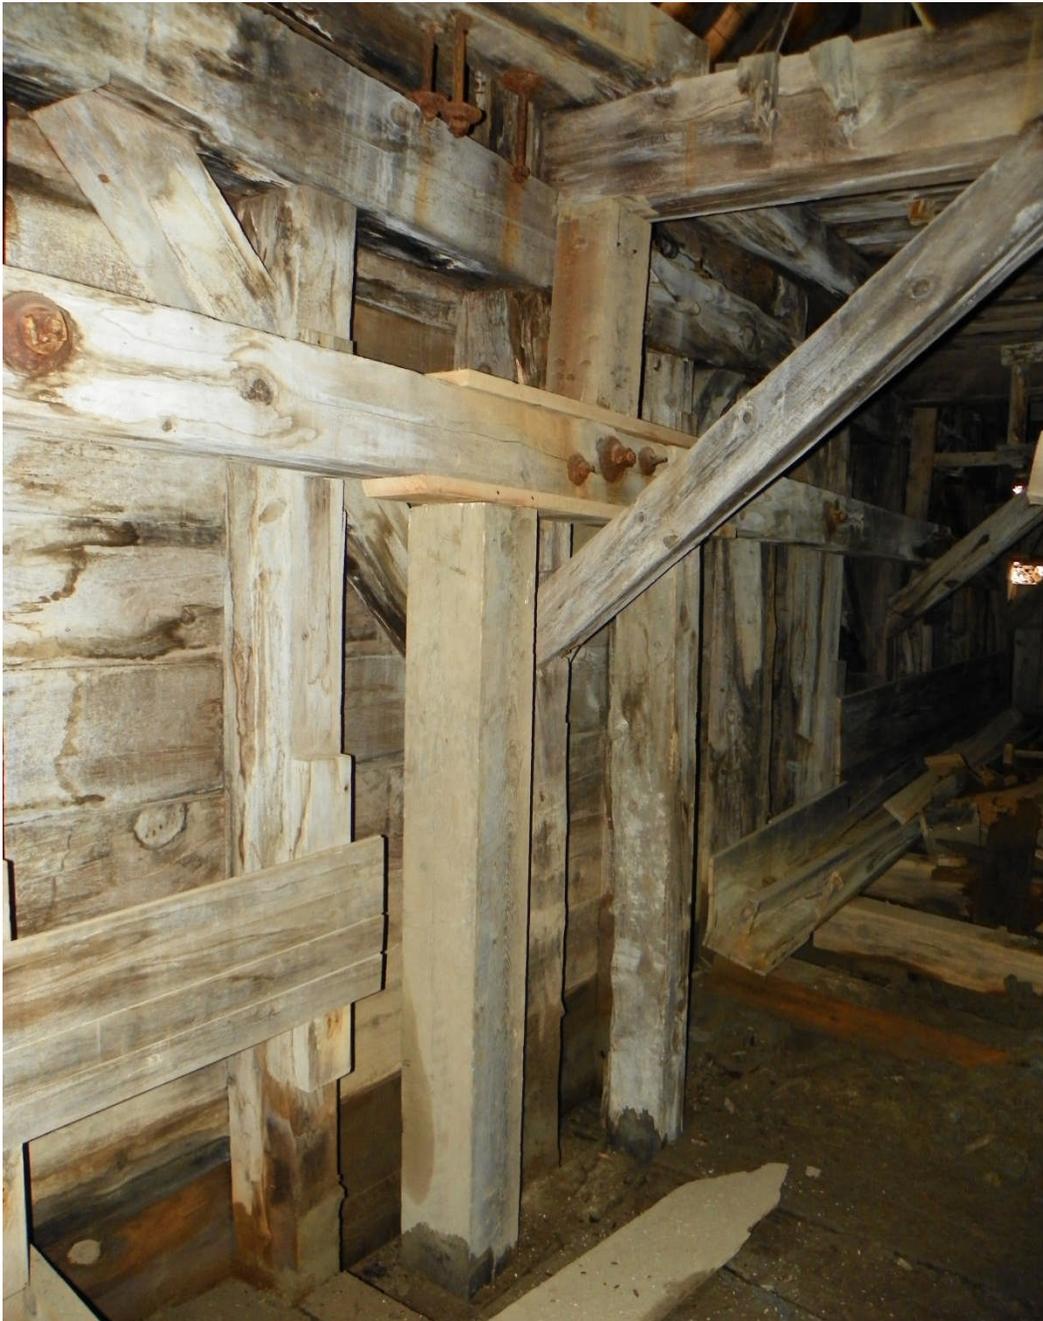
Figure 11

This wall was the westerly wall (Grid 6) of the Concentrate Storage Bin. Repairs were completed at Column 6F (new post and brace); Column 6E (new braces); and, Column 6C (pony sets and support of Level 2 Floor Beam). In addition, Column 5E and 5C were reinforced and a floor beam support post installed along Grid 5 between Column Lines E and F.

Pony Set installed to support Column 6C and Floor Beam between Grid 5 and 6

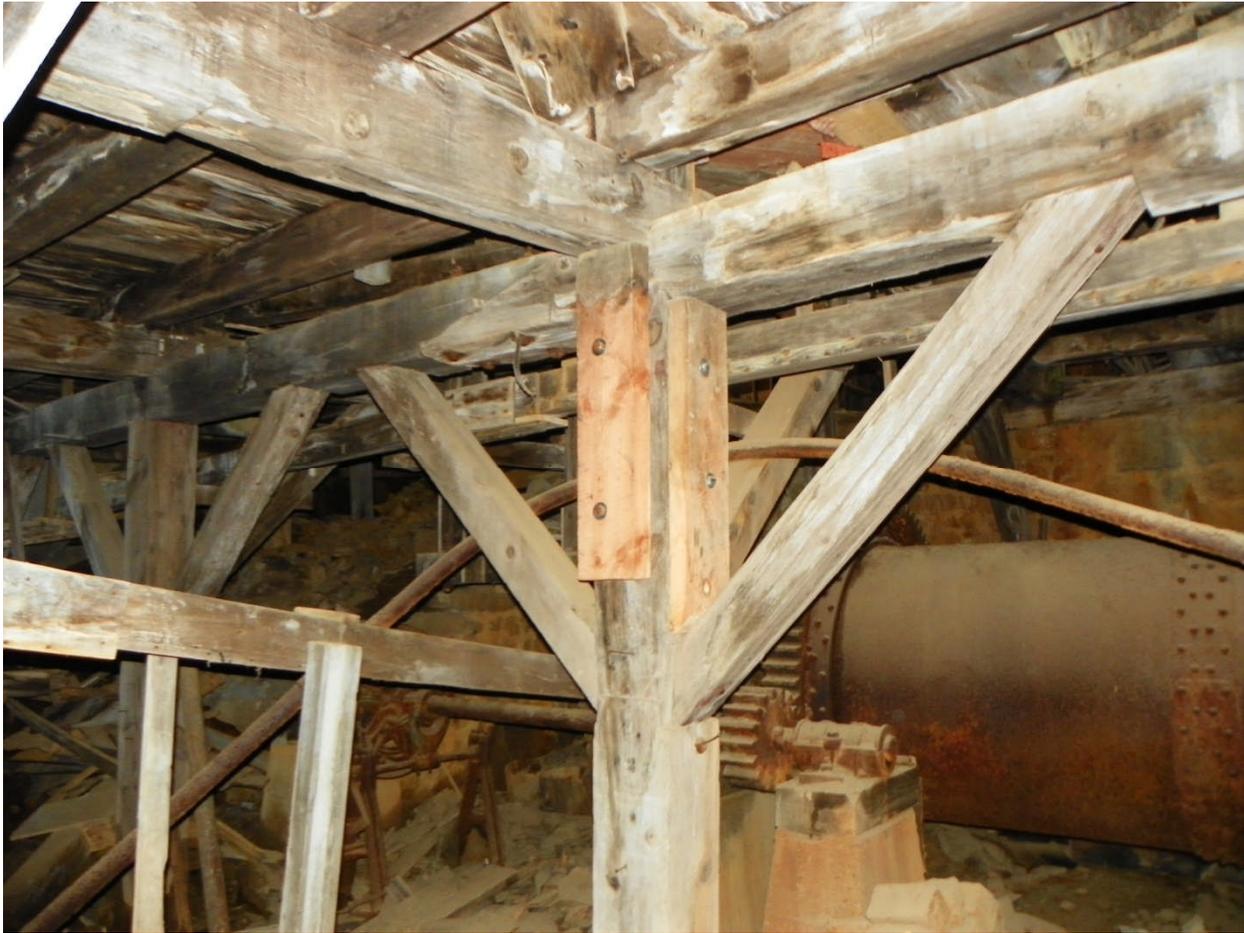
Figure 12

Repair of Column 5C Supporting Level 2

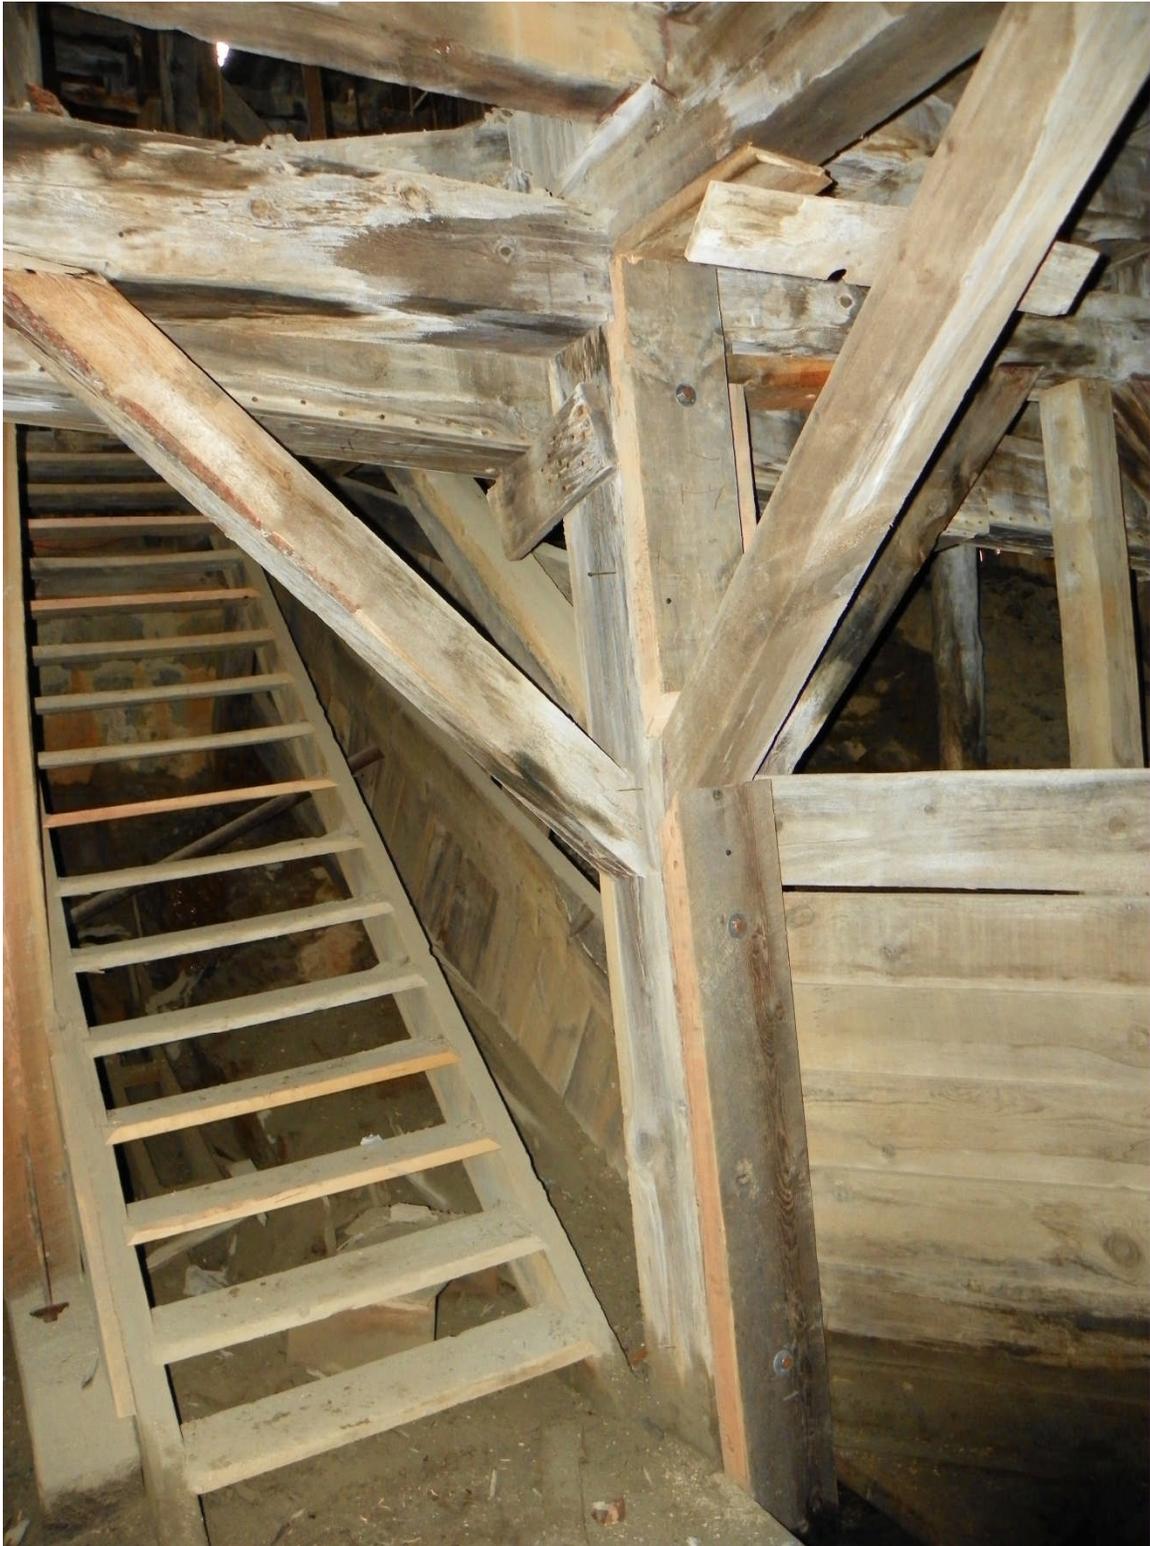
Figure 13

In addition to the reinforcement of Column 5E and the post installed along Grid 6 between Column Lines E and F, the Stairway between Levels 1 and 2 was repaired (Item 11).

Extensive Reinforcement/Repairs of Column 5E and Repaired Stairway between Levels 1 and 2  
Intermediate Post between Column Lines E and F in Background at Photo Right

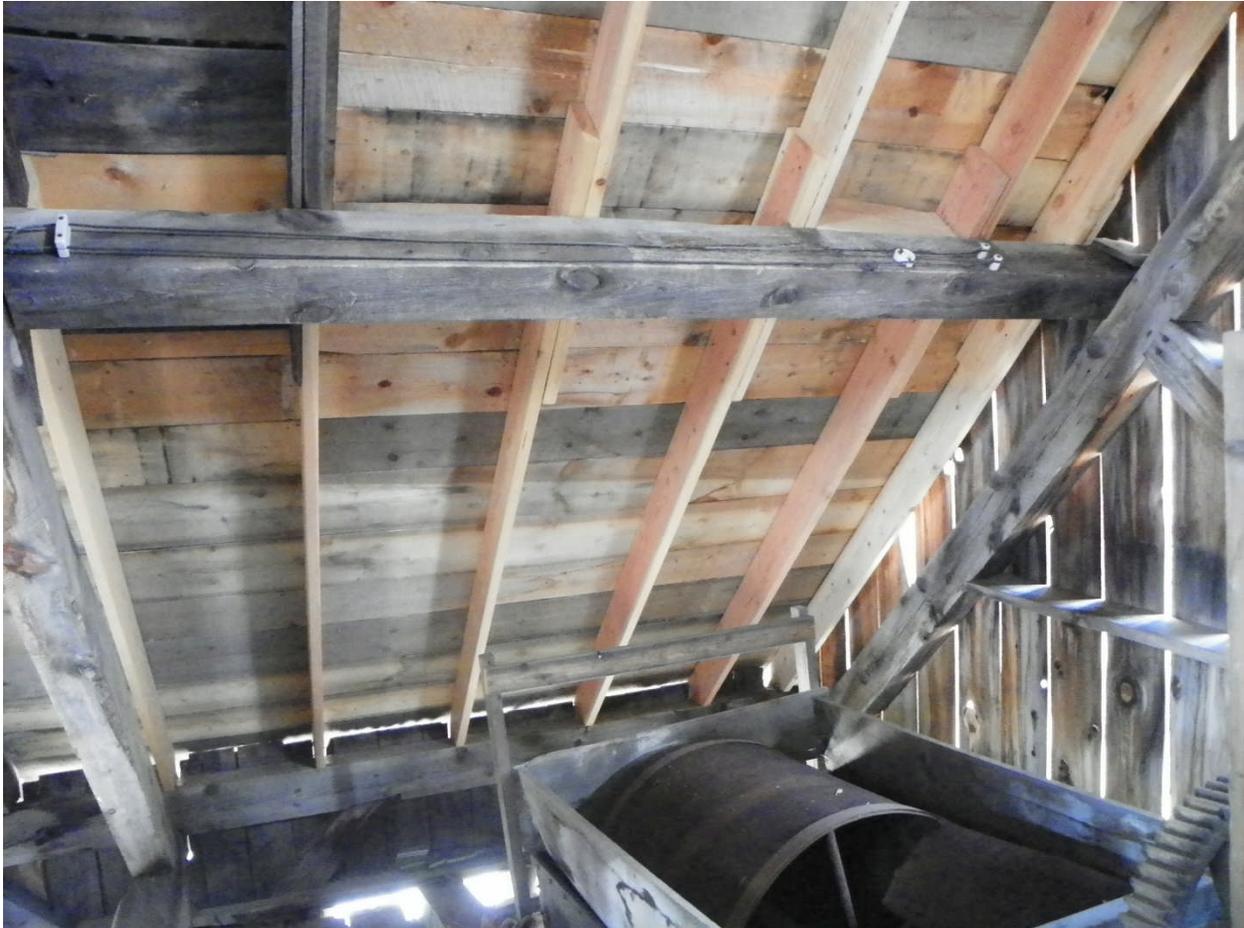
Figure 14

The southern half of the roof section (between Column Lines C and D and Grid Lines 5 and 6) had been lifted off by high winter winds and folded over the northern half of the section, and was minimally suspended by remnants of metal roofing. The suspended section of roof was removed and replaced. Existing materials were utilized as much as possible and new materials were installed where required. The entire section was secured with metal brackets to prevent a future incident of wind lift damage.

Repaired/Replaced Roof Section from Inside Mill between Column Lines C and D

Roof Section is secured to Roof and Wall Framing Timbers by Metal Brackets

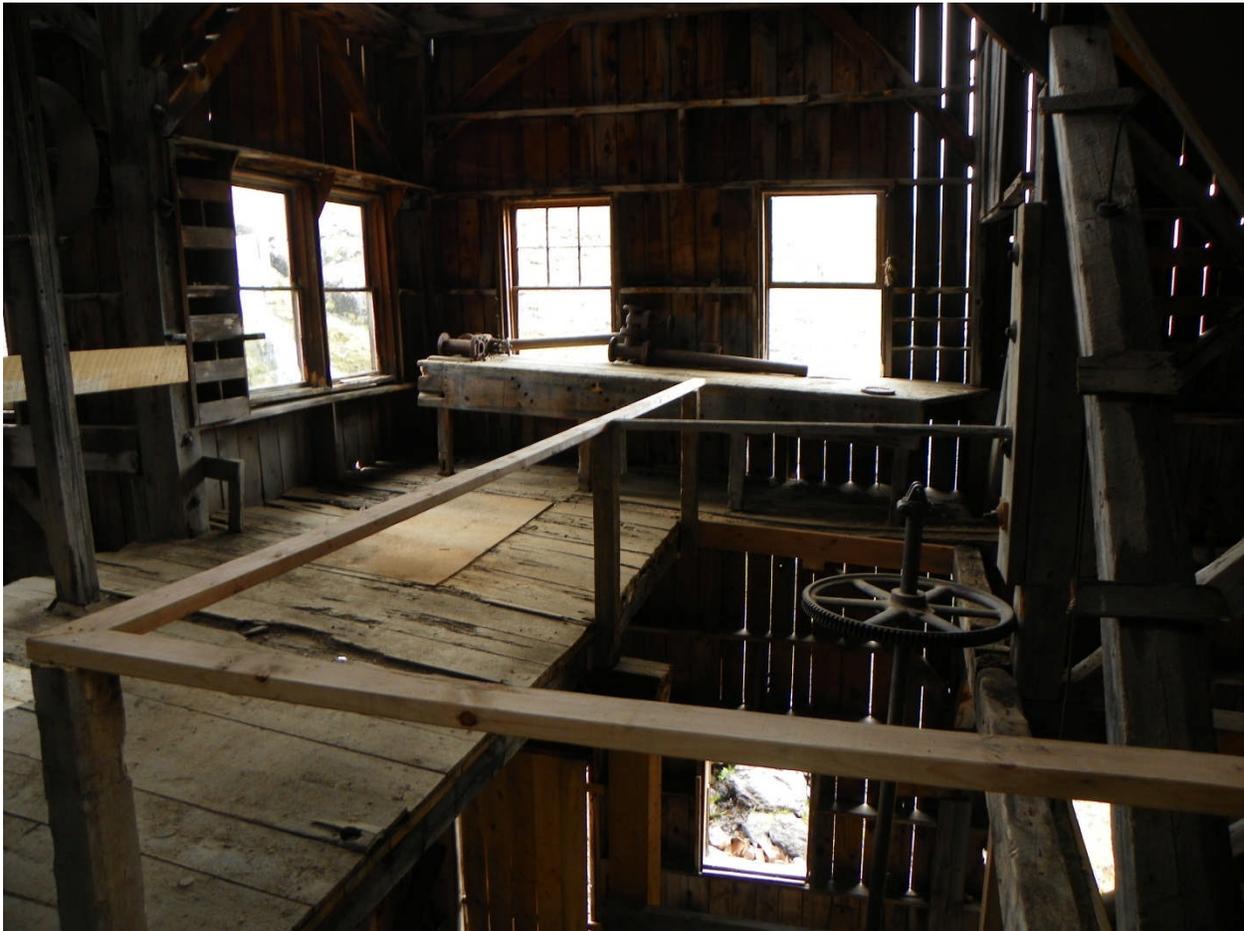
Figure 15

Part of the floor framing supporting Level 3 was repaired and safety rails installed around the remaining openings. The unsafe/unsupported sections of floor were removed.

Level 3 Repaired/Removed Floor Sections and Safety Railings Above Thickener.

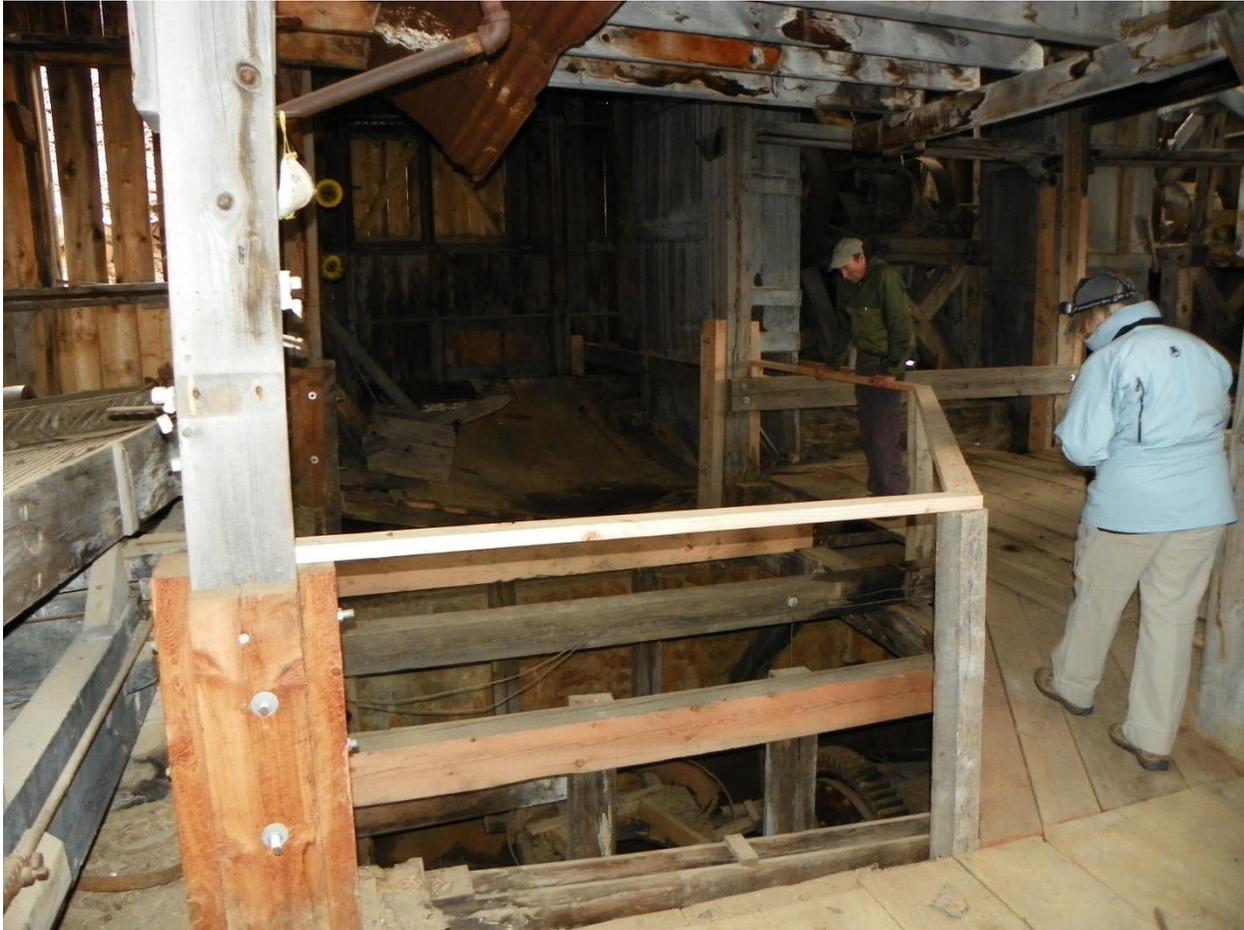
Figure 16

Collapsed floor was removed; new support beams installed as needed. Part of the floor was left open to provide light and viewing of Tube Mill on Level 1. Safety railings were installed around the open area.

Repaired Floor Area, New Floor Beams and Safety Railing with Viewing Area between Column Lines B and C and Grid 4 and 5.

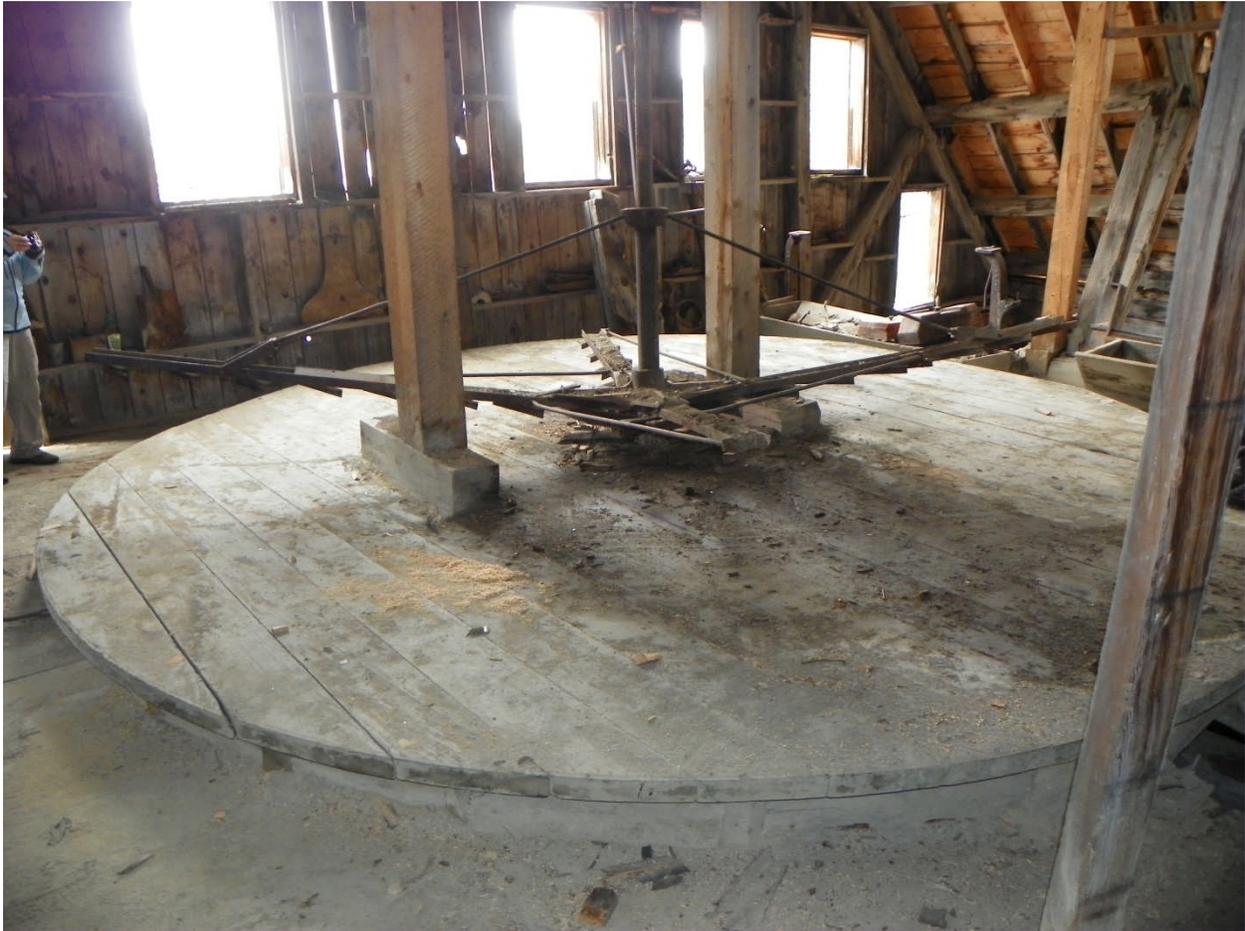
Figure 17

Cleaned Thickener Base and Surrounding Floor on Level 2

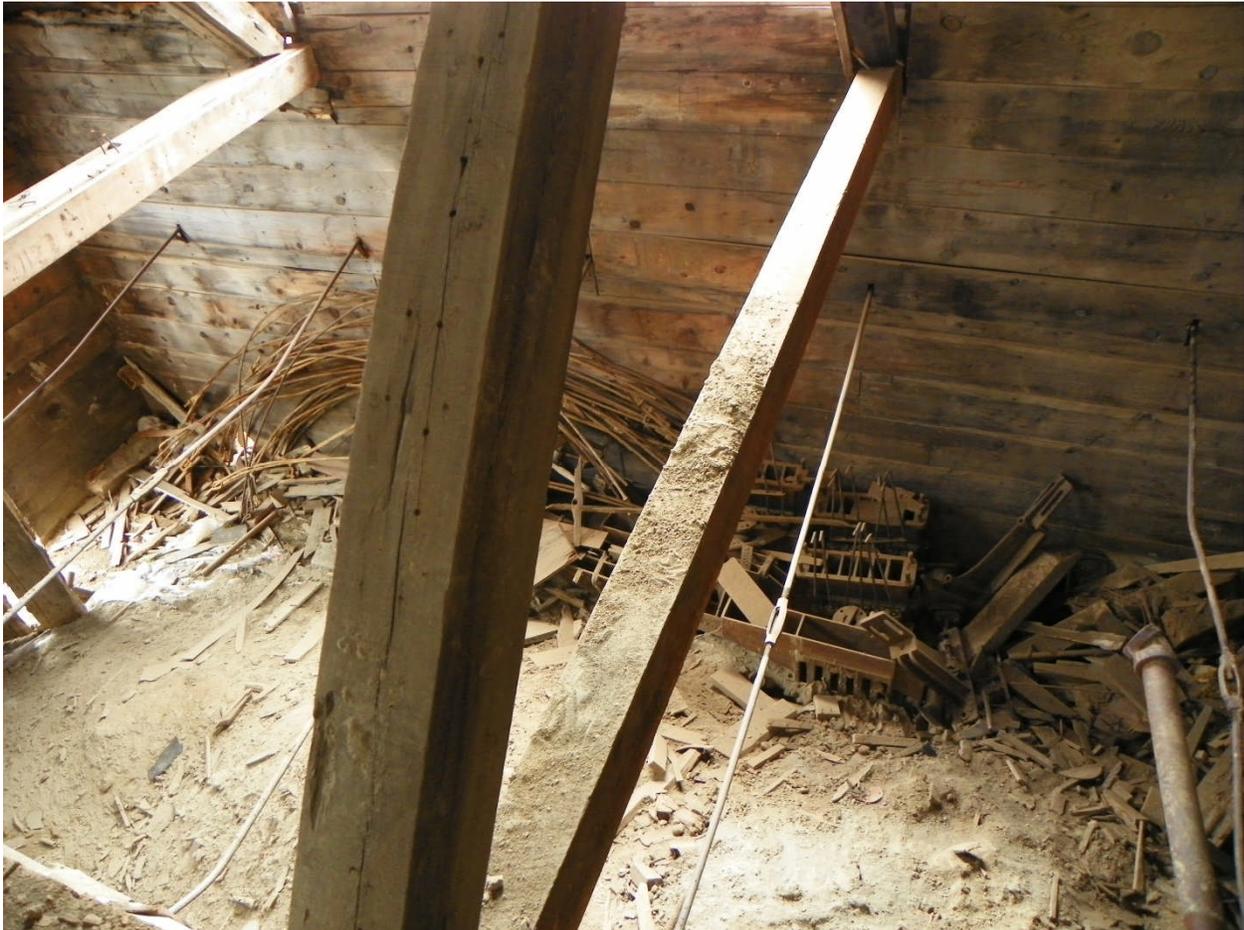
Figure 18

All thickener debris was removed from Level 2 floor and placed in the Concentrate Bin (Figure 18). Equipment items were placed in the concentrate bin for future restoration.

Equipment and Thickener Floor Material in the Concentrate Bin

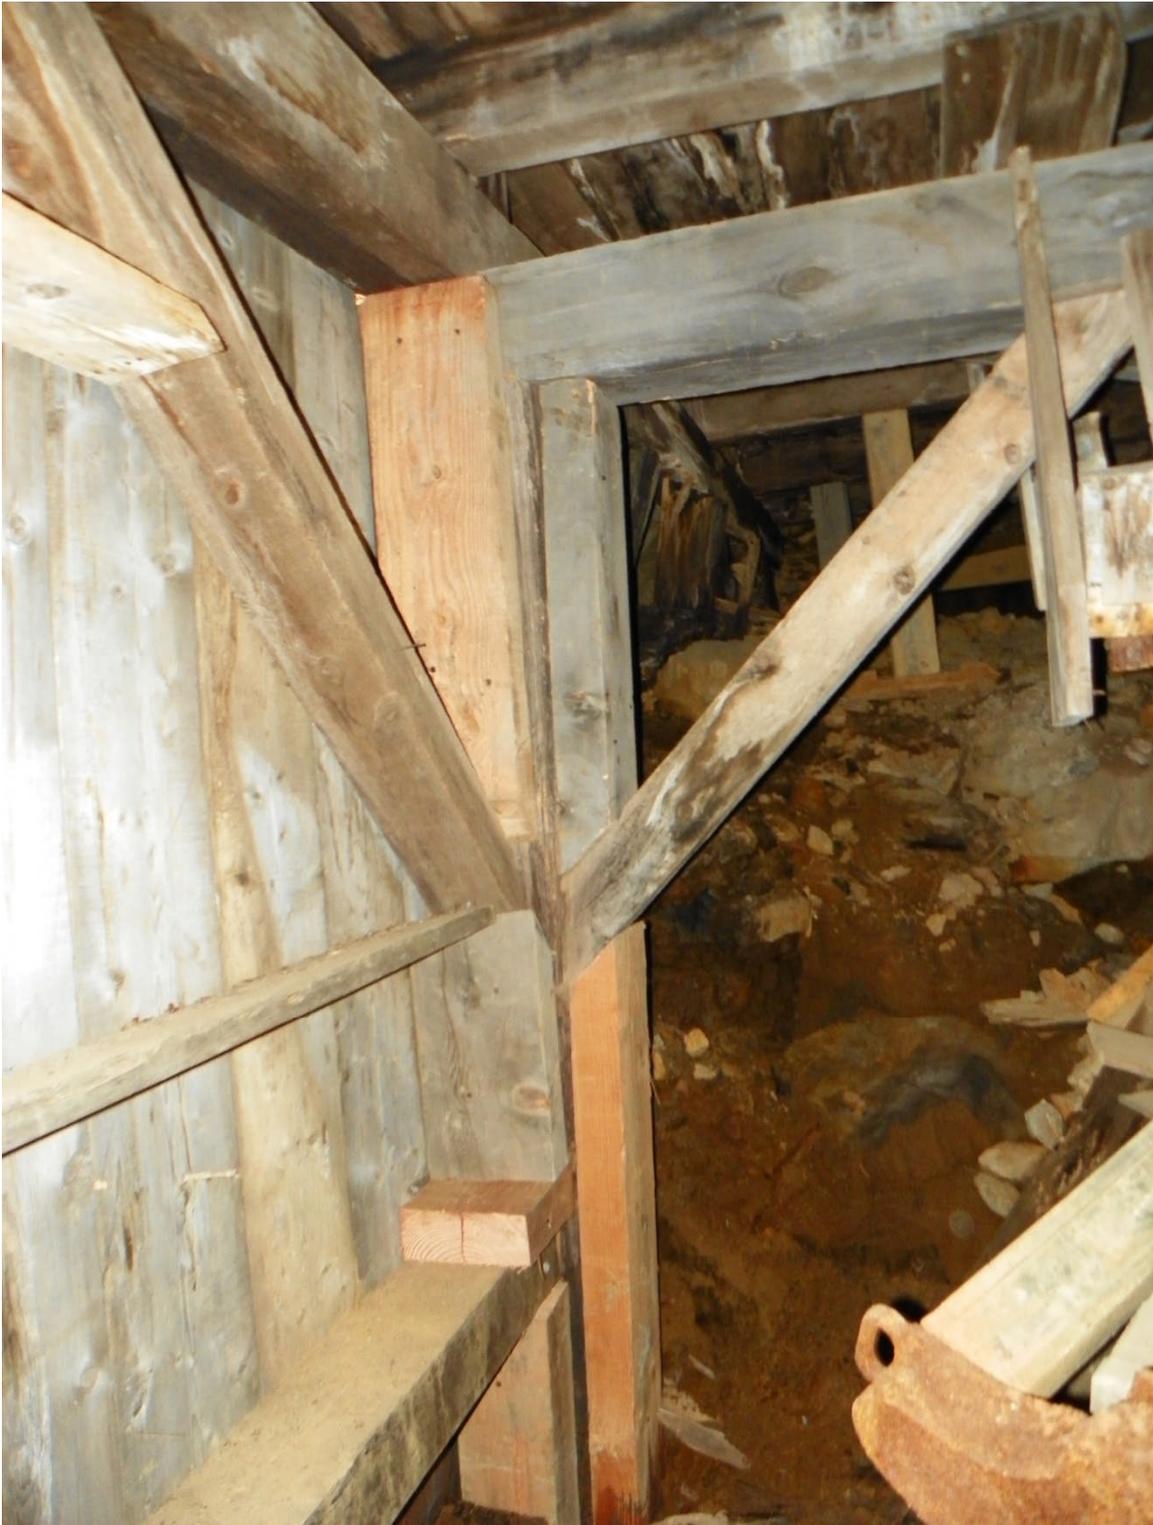
Figure 19

Column 5A was reinforced as shown in Figure 19.

Stabilization of South Wall framing on Level 2

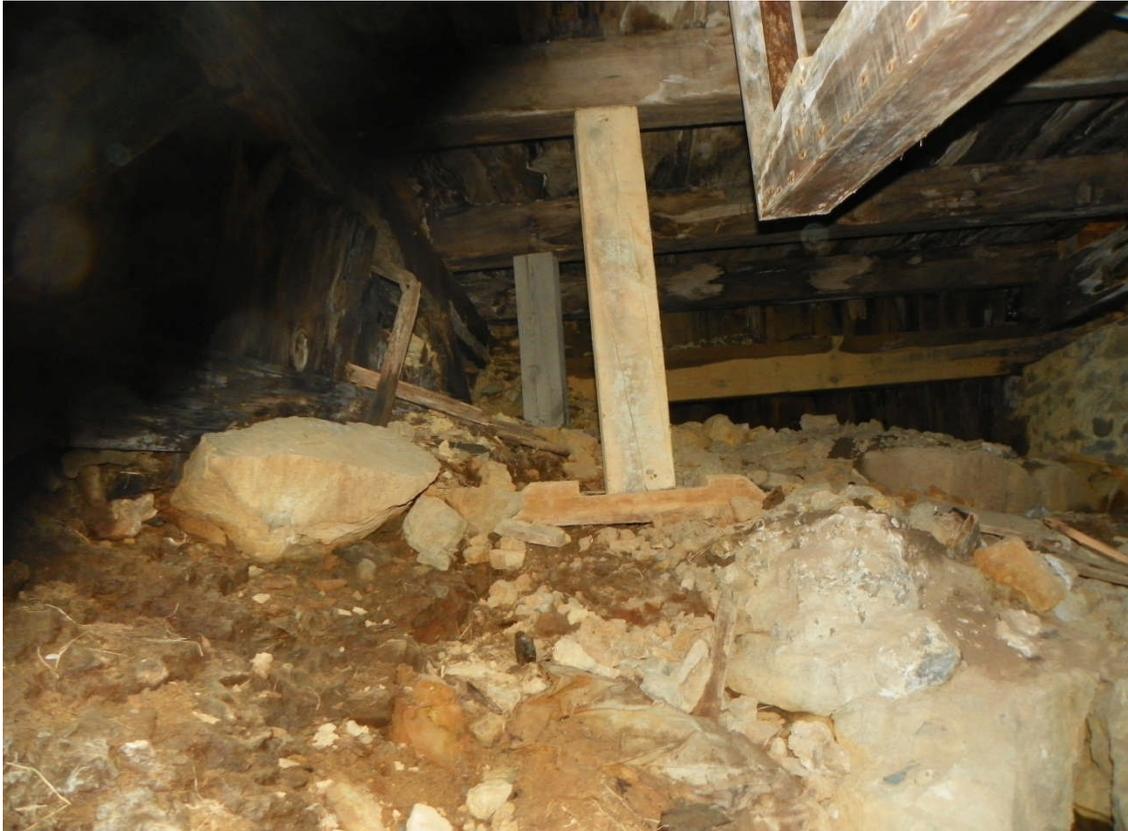
Figure 20

15. Additional floor support posts were placed underneath Level 2 floor between Column Lines A and G and Grid Lines 4 and 5 as shown in Figure 20.

Support Posts underneath Floor Beams between Column Lines A and G and Grid Lines 4 and 5
