**LEWIS MILL**

**2012 Stabilization Project**

**San Miguel County, Colorado**

**FINAL REPORT**

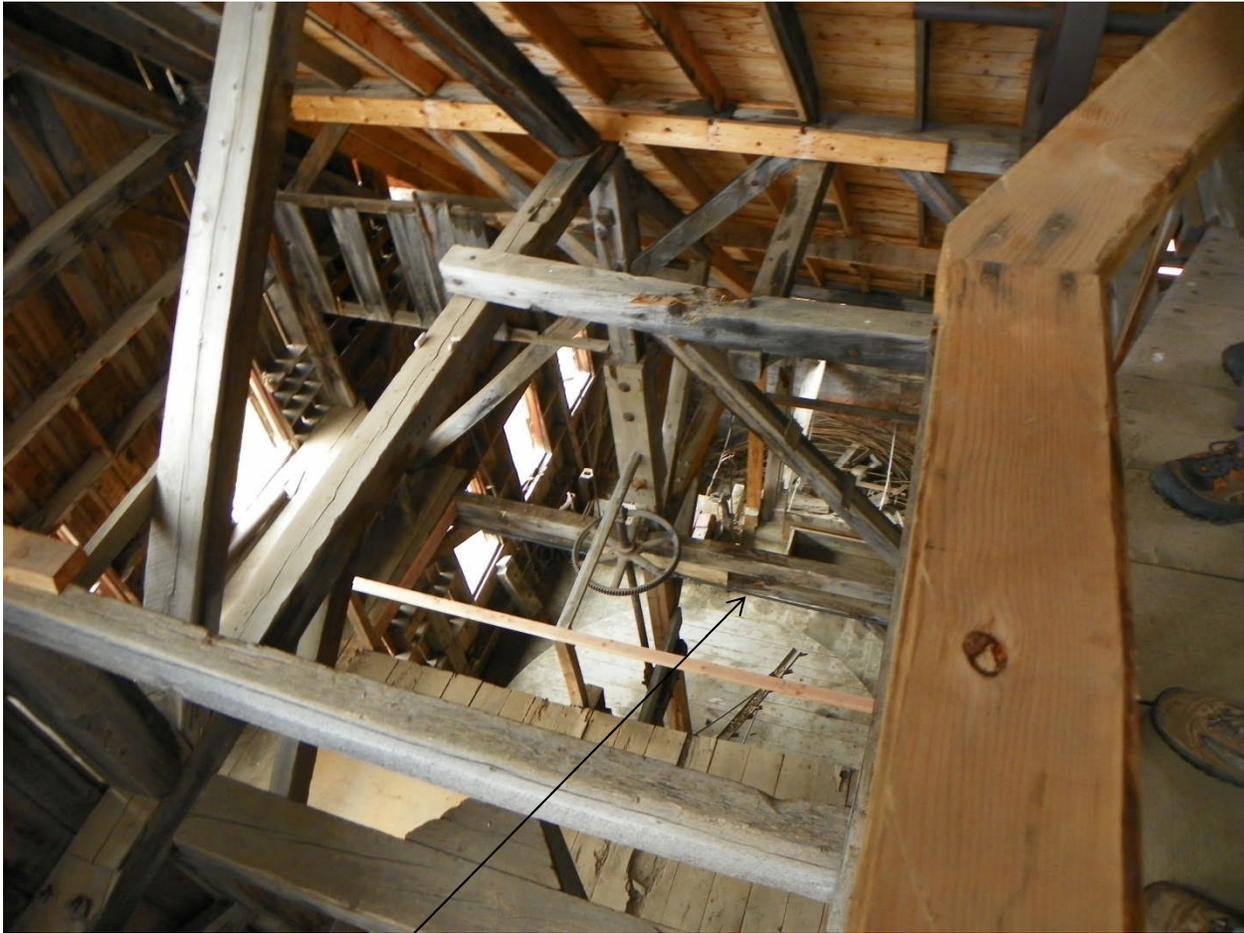
Figure 21

16. A temporary stabilizing tension rod was installed between Column Lines E and G along Grid Line 5 to help stabilize a bulge in the north wall (Column Line G). This is part of the structural problem created when the thickener was installed and column F5 was removed between Level 2 and Level 3. This continues to be an area of structural weakness in the building framing. The Rod is shown in Figure 21.

Location of Tension Stabilizing Rod along Grid Line 5

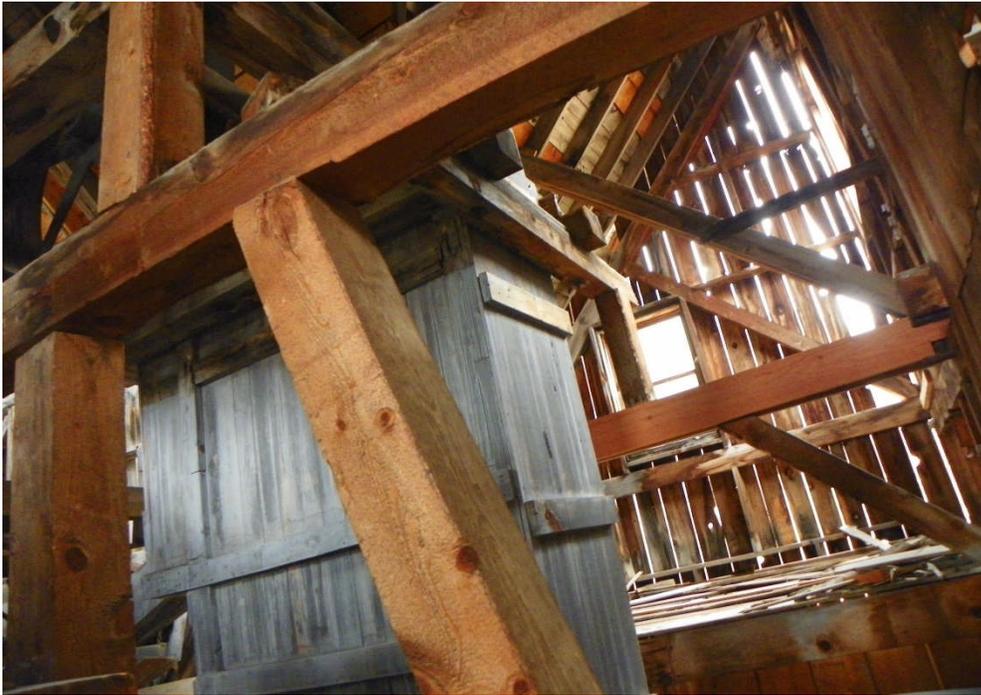
Figure 22

Additional Support at Top of Bucket Elevator Shaft No. 5

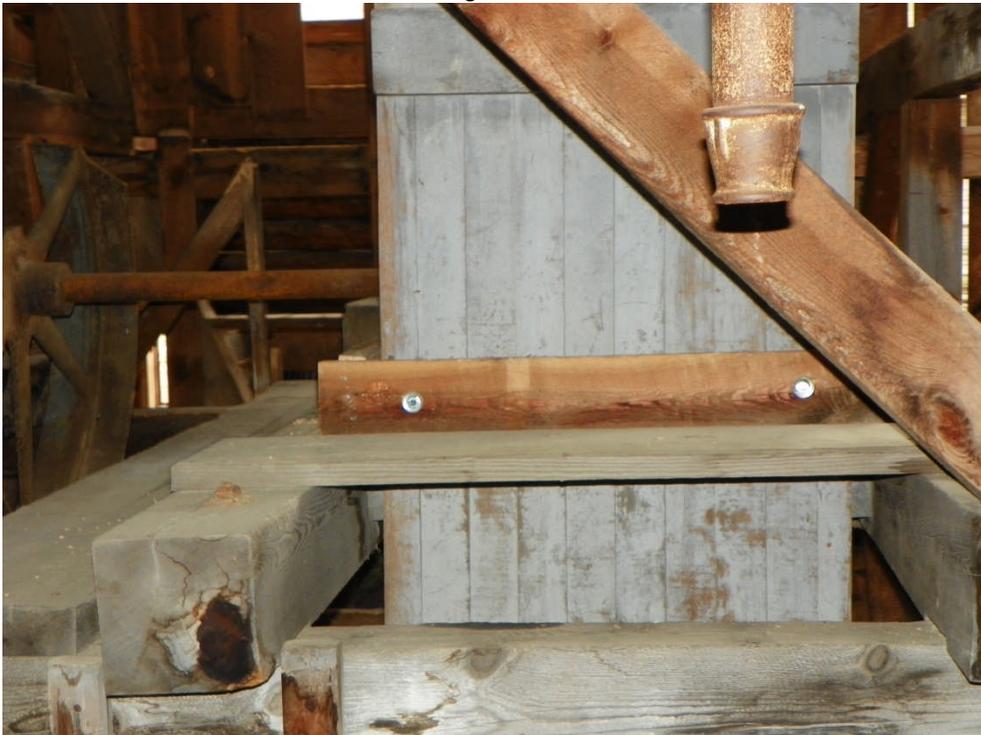
Figure 23

Additional Support at Top of Bucket Elevator Shaft No. 6

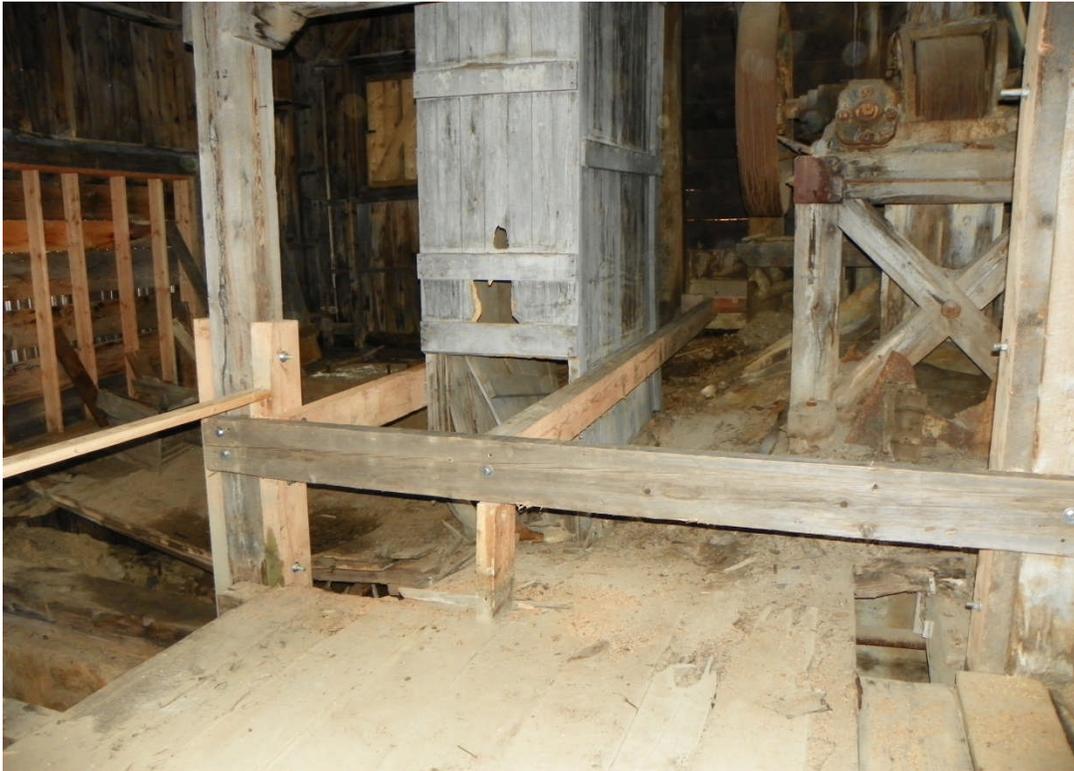
Figure 24

Additional Support at the Bottom of Bucket Elevator Shaft No. 5

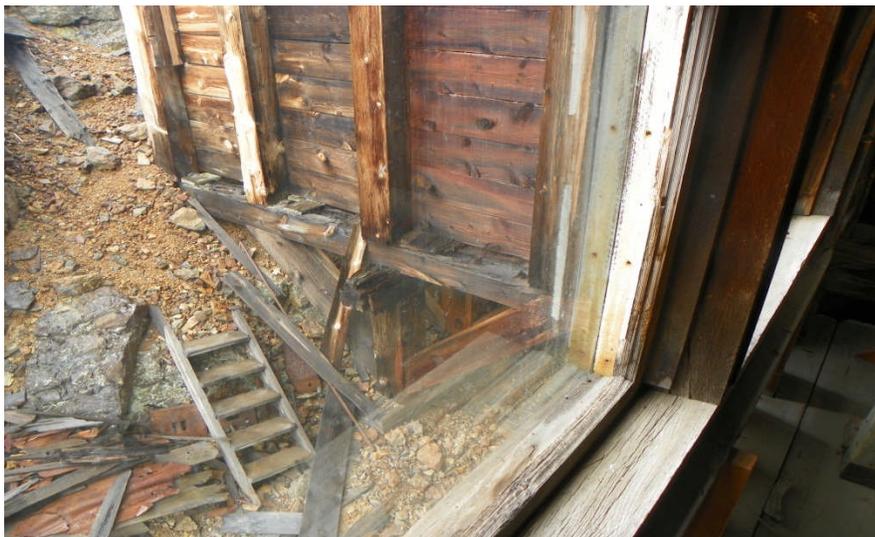
Figure 25

Crushed Ore Bin Bottom – South Side Column Line C, Grid Line 2.

1. Support bottom of bucket elevator 6 housing.
2. Support top and bottom of bucket elevator 7 housing.
3. Repair deteriorated structural timbers of the crushed ore bin located at Column Line C and Grid Line 2.
4. Provide additional stabilization of the north wall (Column Line G) at Grid Line 5. This is a high priority item.
5. Monitor stability of lateral resisting frame along Column Line 4.
6. Complete window closures to prevent accumulation of snow inside of building.
7. Repair rotten beam and post elements of northeast dormer
